# Manhole Inspection Summary

Manhole # S09WW\_017MH

Insp Date: **4/10/07 11:13 AM**

**Location** Address: **3405 GRANTLEY RD**

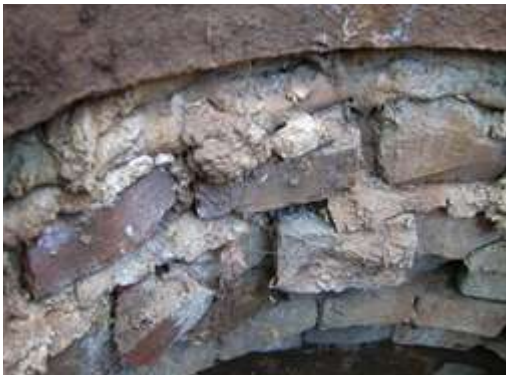
Defect 1

Condition: ☐ Sound ☐ Cracked ☐ Root Intrusion ☒ **Loose Brick** ☐ Deteriorated

LOOSE BRICKS AND DETERIORATED  
AT CORBEL

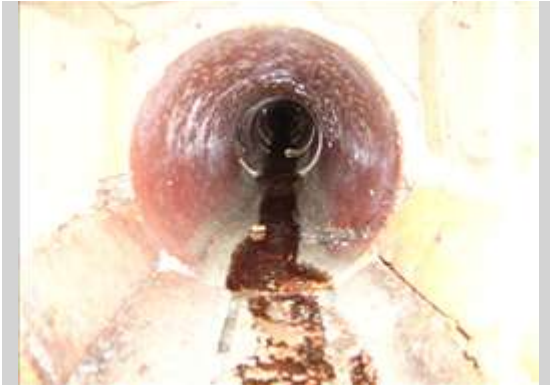
12 O'Clock Outflow

8 in. Circular Gravity Sewer  
Pipe Out @ 12 O'Clock

Pipe Height: (in.) Direct  
Pipe Material: **Clay** ☐ Pipe Lined  
Invert Depth: **6.28** (ft.) Flow Characteristics: **Slow**  
Deposits: ☒ None ☐ Mud ☐ Sludge ☐ Debris ☐ Grease  
Silt Depth: (in.) Deposits Extent:  
Infiltration: **None** Pipe Seal Cond: **Sound**

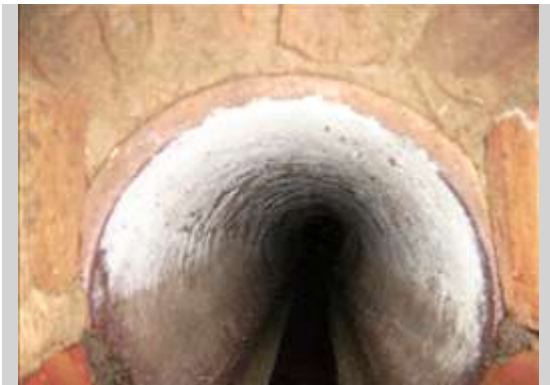
6 O'Clock Inflow

8 in. Circular Gravity Sewer  
Pipe In @ 6 O'Clock

Pipe Height: (in.) Direct  
Pipe Material: **Clay** ☐ Pipe Lined  
Invert Depth: **6.25** (ft.) Flow Characteristics: **Slow**  
Deposits: ☒ None ☐ Mud ☐ Sludge ☐ Debris ☐ Grease  
Silt Depth: (in.) Deposits Extent:  
Infiltration: **None** Pipe Seal Cond: **Sound**
